Manhole Inspection Summary

Manhole # S13O__009MH

Insp Date: **3/25/08 8:24 AM**

Location Address: **2801 Frederick AV**

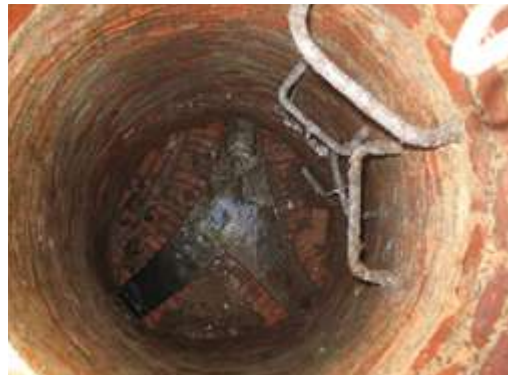
Defect 5

Count: **5** Missing: **0** ☒ **Corroded**

☒ **Evidence Of Surcharge** Depth: **4** (ft.) ☐ Active Surcharge Present

steps corroded, surcharge evidence

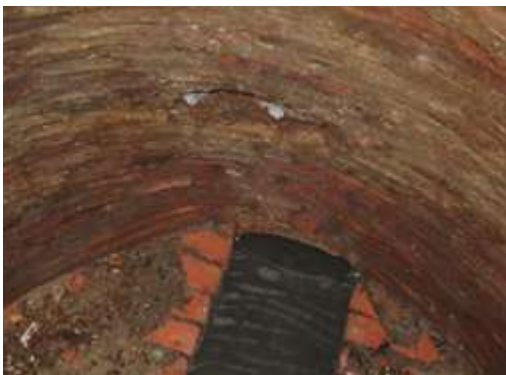
Defect 4

Condition: ☐ Sound ☐ Cracked ☐ Root Intrusion ☒ **Loose Brick** ☐ Deteriorated

barrel bricks missing

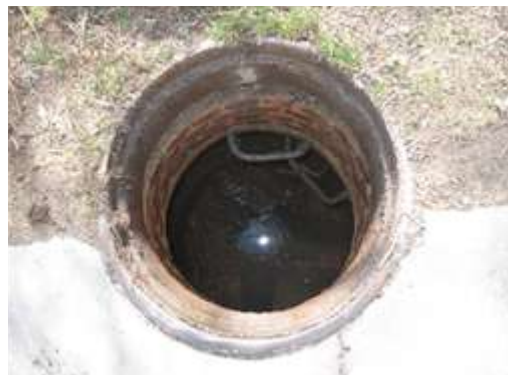
Defect 6

Offset: **2** (in.)

offset

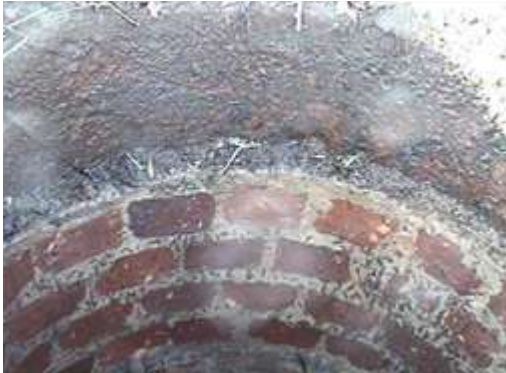
Defect 3

☒ **Leaks**

Infiltration: ☐ None ☐ Joint ☐ Cracks ☐ Mortar ☐ Roots ☒ **Wall**

sign of infiltration at chimney wall and frame

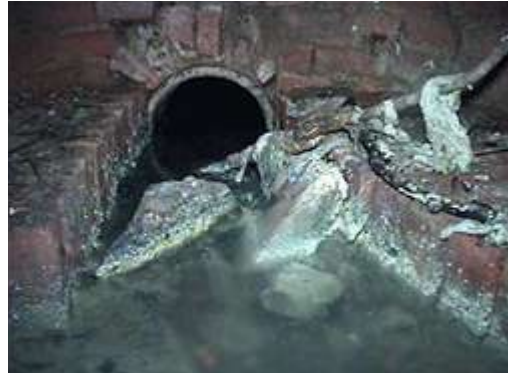
Defect 2

Condition: ☐ Sound ☐ Cracked ☐ Root Intrusion ☐ Deteriorated ☐ Leaks ☒ **Debris**

debris 8 oclk channel 3 inches

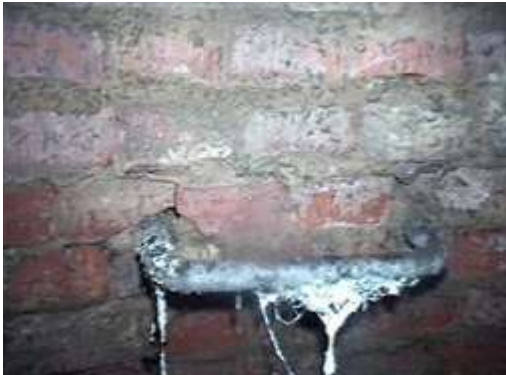
Defect 1

sign of surcharge 4 feet

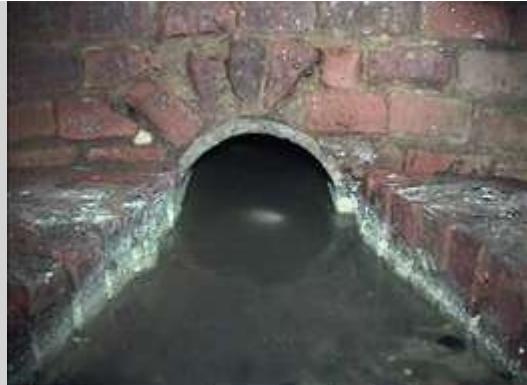
12 O'Clock Outflow

Pipe Height: **8.4** (in.) Rod and Bar (Angled)
Pipe Material: **Clay** ☐ Pipe Lined
Invert Depth: **10.32** (ft.) Flow Characteristics: **Slow**
Deposits: ☒ None ☐ Mud ☐ Sludge ☐ Debris ☐ Grease
Silt Depth: **0** (in.) Deposits Extent:
Infiltration: **Evidence** Pipe Seal Cond: **Unknown**
